Benthic Macroinvertebrate Monitoring in the Spring Creek Watershed

The Water Resources Monitoring Project's
2012 State of the Water Resources Report

BENTHIC MACROINVERTEBRATE MONITORING

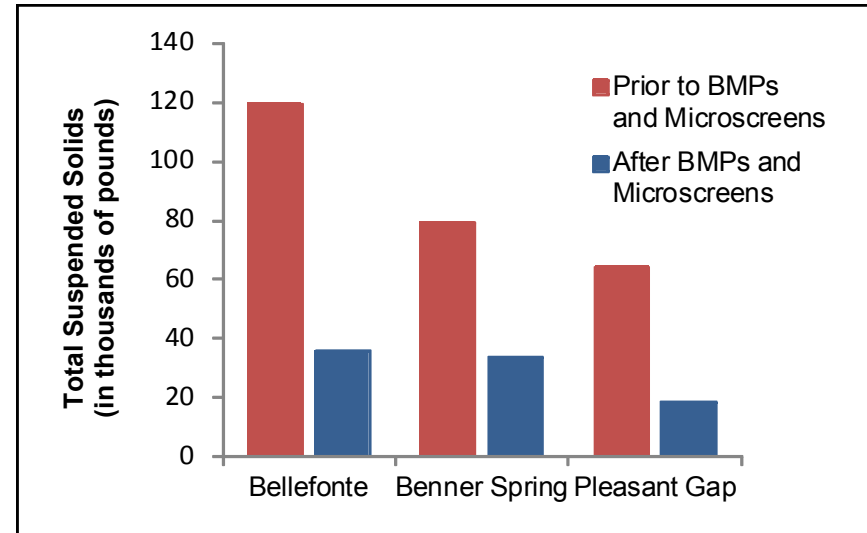
Figure 4. Pound of total suspended solids discharged from the PFBC hatcheries before and after installation of BMPs and microscreen filters. Data courtesy PFBC.

The PFBC undertook an effort to improve the quality of the discharges from the three hatcheries in the watershed. Between 2007 and 2010 they installed microscreen filtration

As noted earlier, the PFBC has installed microfilters to control the amount of particulate nutrients in the discharges from all three hatcheries in the watershed. The IBI data from PFBC has indicated improved water quality downstream from the Pleasant Gap hatchery on Logan Branch but little evidence to date for improvement downstream of the Benner Spring or Bellefonte facilities on Spring Creek (**Table 7**). The microfilters remove particulates: dissolved nutrients and organic matter pass through. Dissolved organic matter feeds bacteria and fungi which in turn feed sowbugs (Gammaridae), a pollution tolerant organism whose presence in large numbers will reduce the IBI score (Robert Carline, personal communication).

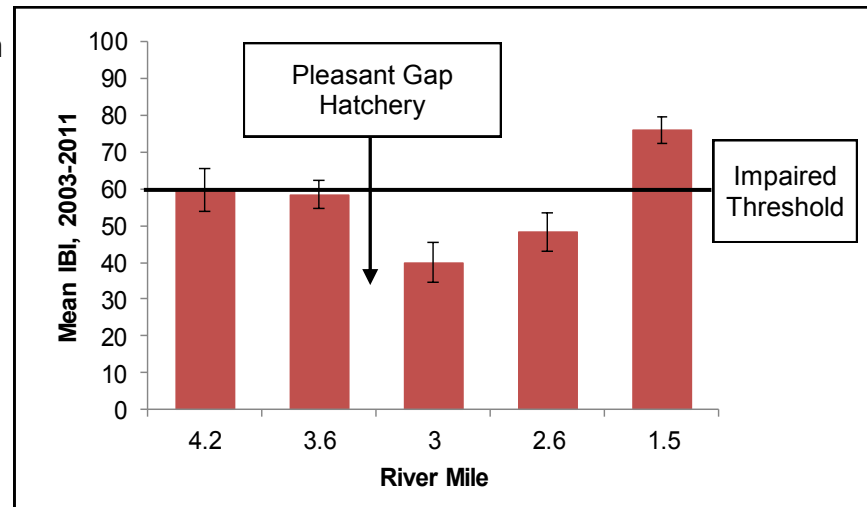
Figure 5. Mean IBI values on Logan Branch, 2003-2011. Data courtesy PDEP and PFBC. Error bars represent standard error.

on page 12. Historically, a decrease in IBI score is seen immediately downstream of the hatchery, with a recovery to unimpaired conditions by river mile 1.5, located upstream from Bellefonte. Sites near the hatchery operations are also subject in impacts from mining operations in the area that discharge excess water from quarries. Since microscreen filters were installed at the hatchery in 2007, the IBI scores downstream of the discharge have improved.

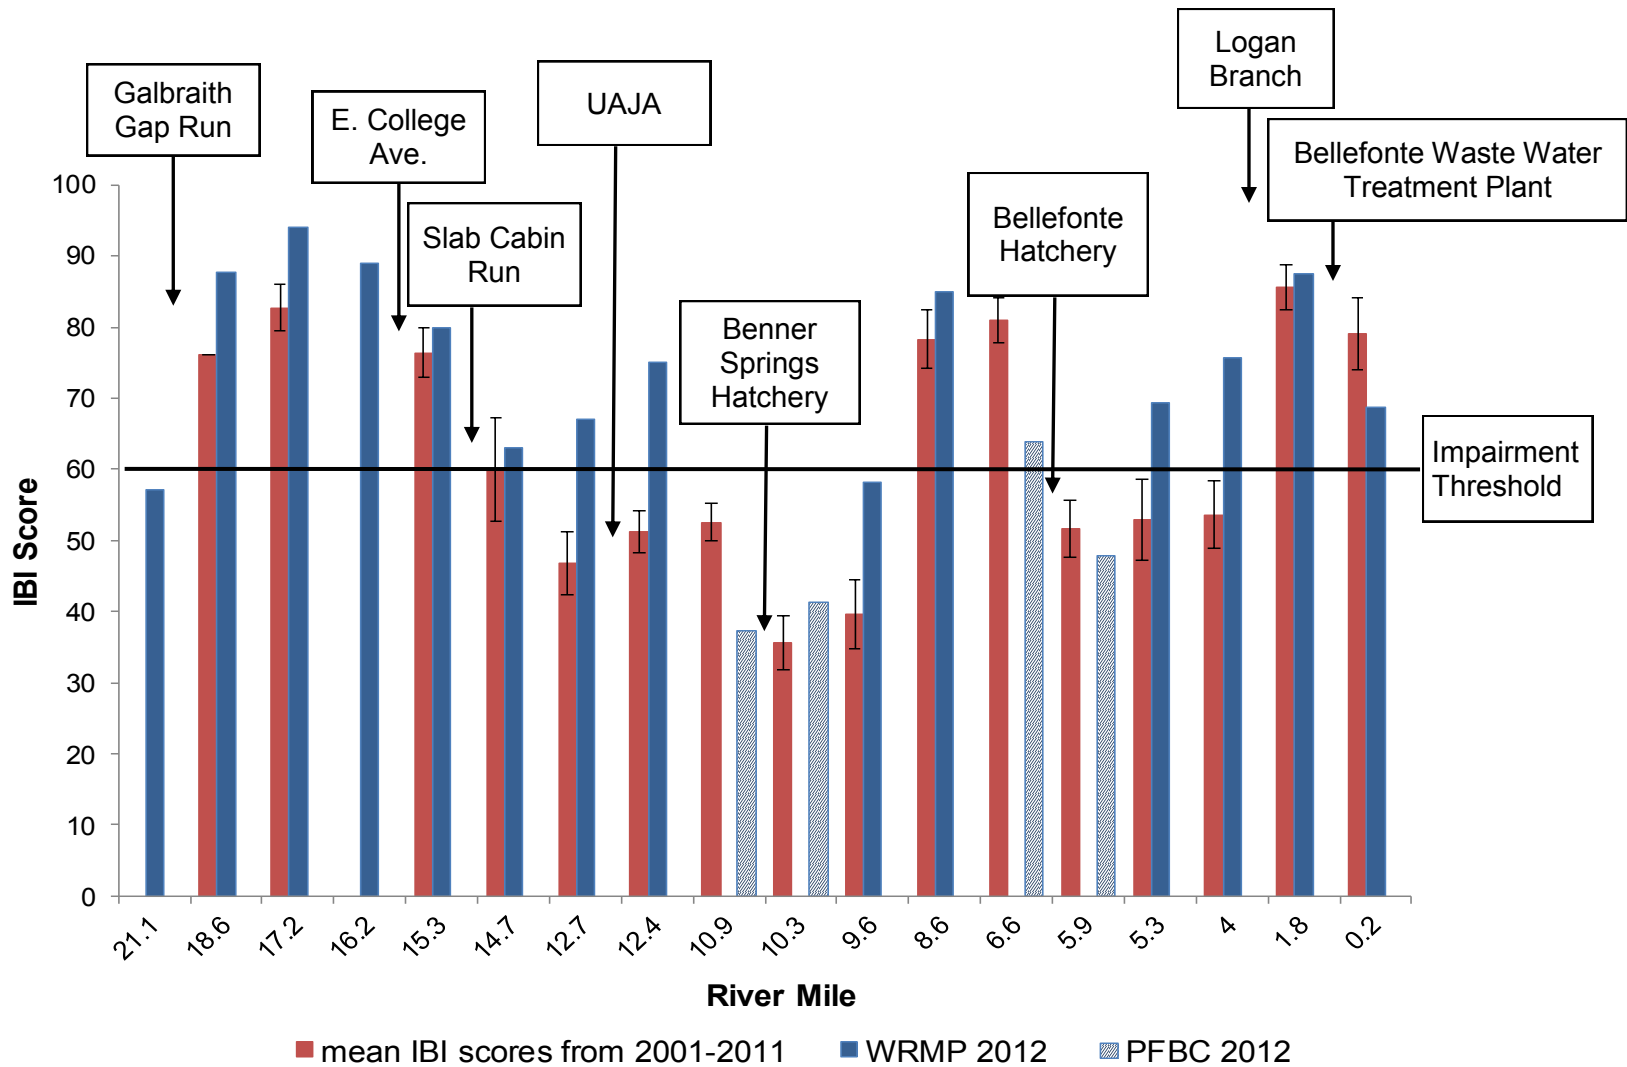
Figure 6. IBI results for 2012 from the main stem of Spring Creek. Error bars for mean data from 2001 to 2011 represent standard deviations.

Results from the 2012 WRMP survey on the main stem of Spring Creek are found in **Figure 6** on page 15 and **Table 5** on page 16. Data from the PFBC surveys upstream and downstream of their hatchery facilities are included. Results indicate non-impaired conditions at all WRMP sites

sampled on Spring Creek, with the exception of the site at river mile 9.6 downstream from the Benner Spring Hatchery and the headwater location at river mile 21.1. Pennsylvania Fish and Boat Commission data indicated impaired conditions at the two hatchery locations. As seen in past years surveys, there was a drop in scores observed downstream of urbanized State College, in particular below the confluence with Slab Cabin Run.

The lowest WRMP score observed on Spring Creek was near the headwaters at river mile 21.1 at a site located just downstream of Fasick Memorial Park and upstream of the confluence with Galbraith Gap Run. There is land development on either bank at this location, but the low score may also be influenced by the site's headwater location, where unique food webs can influence macroinvertebrate communities¹⁶.

In past surveys, there has usually been a drop in IBI score between river mile 14.7 and 12.7. This area receives discharges from the Shilo Road area and the Big Hollow. There was an increase in IBI score observed between these points in 2012.

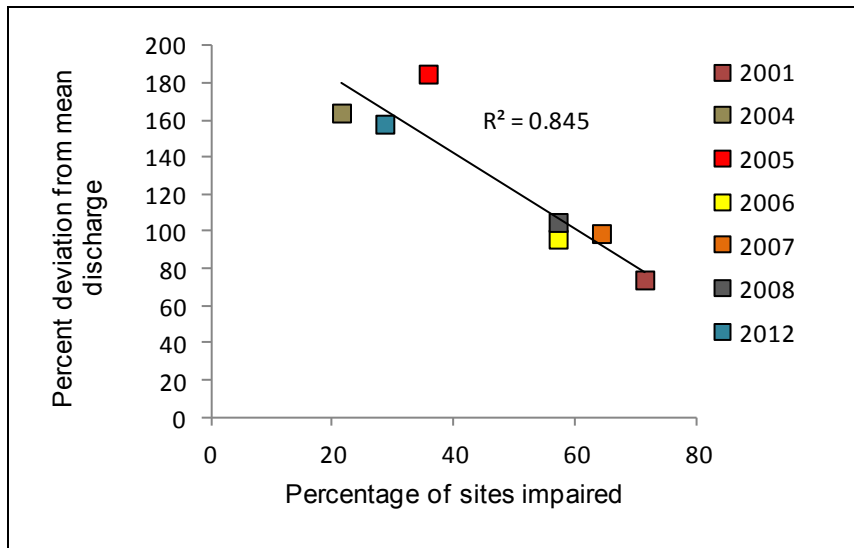
Figure 7. Deviation in Spring Creek discharge prior to IBI sampling versus percent of sites impaired in years 2001, 2004 through 2008, and 2012.

Discharge at Axemann USGS stream gage from http://waterdata.usgs.gov/usa/nwis/uv?site_no=01546500, with assumed April 1 sample date. Percent of sites impaired includes only the fourteen sites surveyed in each of the Spring Creek surveys conducted in 2001, 2004 through 2008, and 2012.

The 2012 IBI scores at sites in Spring Creek were generally higher than the average scores for these sites from 2001 through 2008. Robert Carline, an aquatic ecologist formerly at the Pennsylvania Cooperative Fish and Wildlife Research Unit, had noted that above average stream discharge typically results in higher IBI scores across all sites while below average discharges result in lower IBI scores across all sites (Robert Carline, personal communication). This relationship is seen in **Figure 7** on page 18 which plots the discharge data for Spring Creek at the USGS Axemann stream gage against the percent of sites impaired in IBI surveys conducted between 2001 and 2012. The discharge of Spring Creek at the Axemann gage over the twelve months prior to the 2012 sample

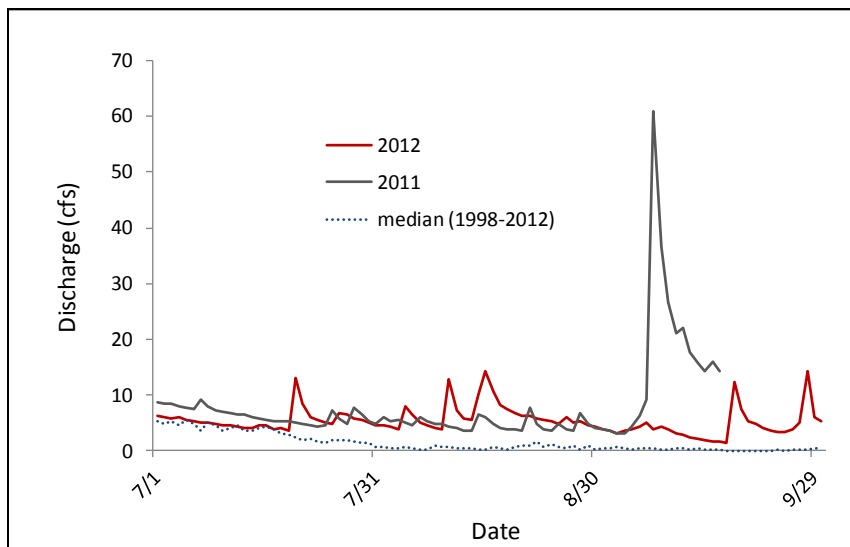
Figure 18. Average daily discharge at Slab Cabin Creek below East College Avenue from July 1, 2012 to October 1, 2012.

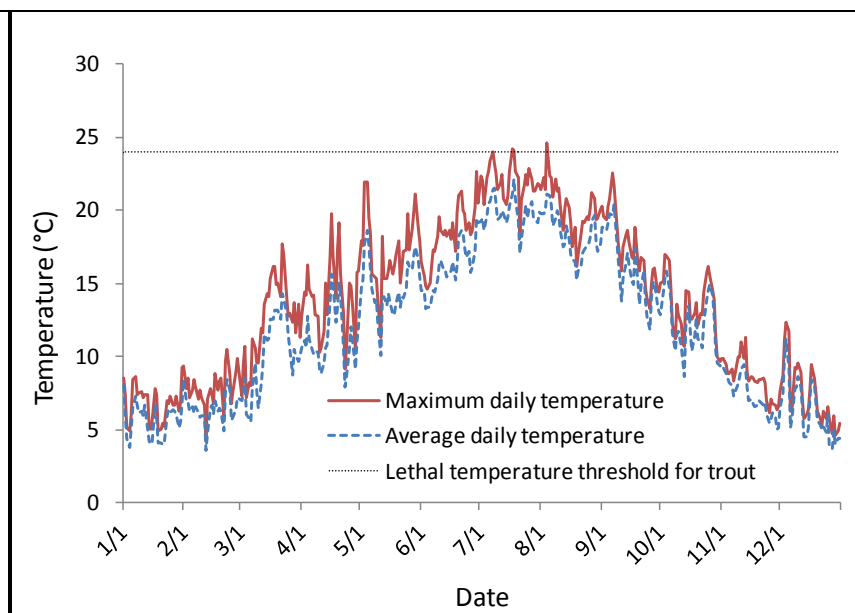
Figure 20. Maximum and average daily temperatures at Slab Cabin Run at College Avenue in 2012.
